## **This is an example of my level 2 home buyer report.**

It is taken from an actual survey done on a 1950's built, 3 bedroom, semi-detached property.

## Section 4 - Outside of the Property

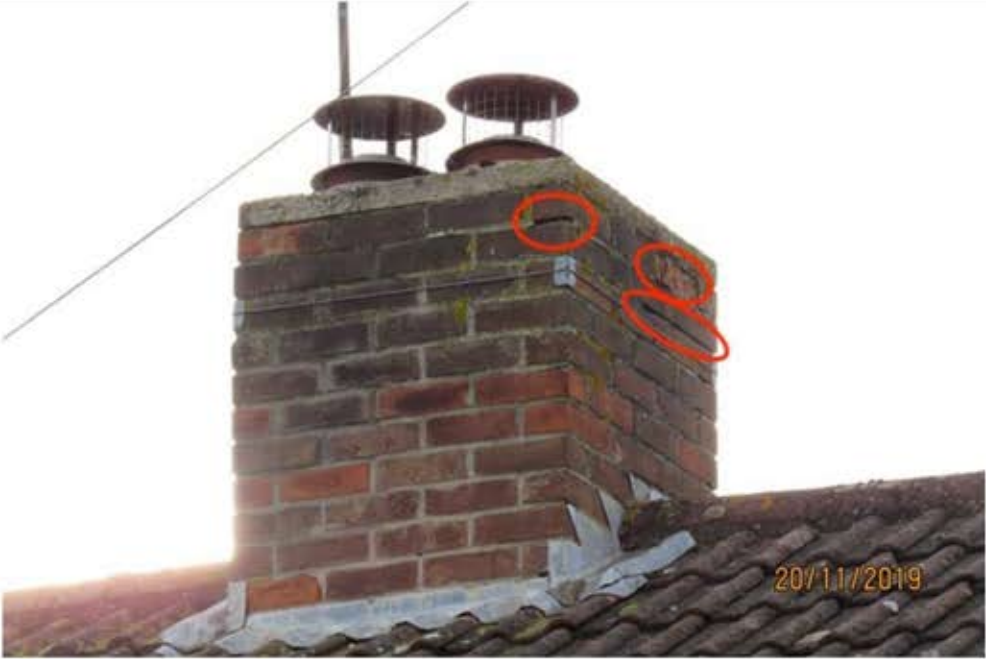
<p>20/11/2019</p> <p>Front view of east chimney stack</p>

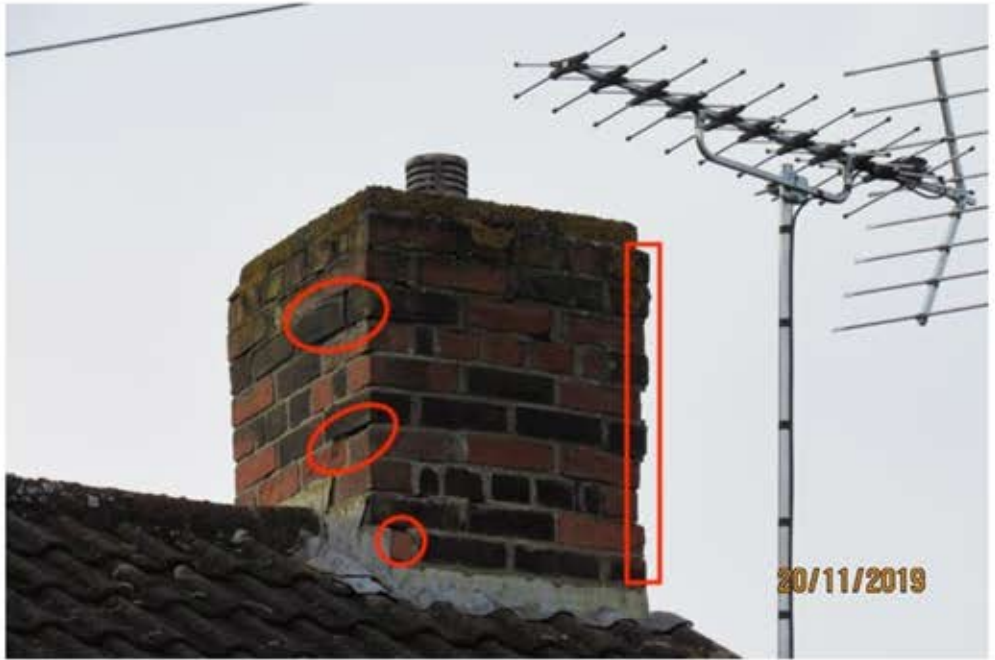
Front view of west chimney stack

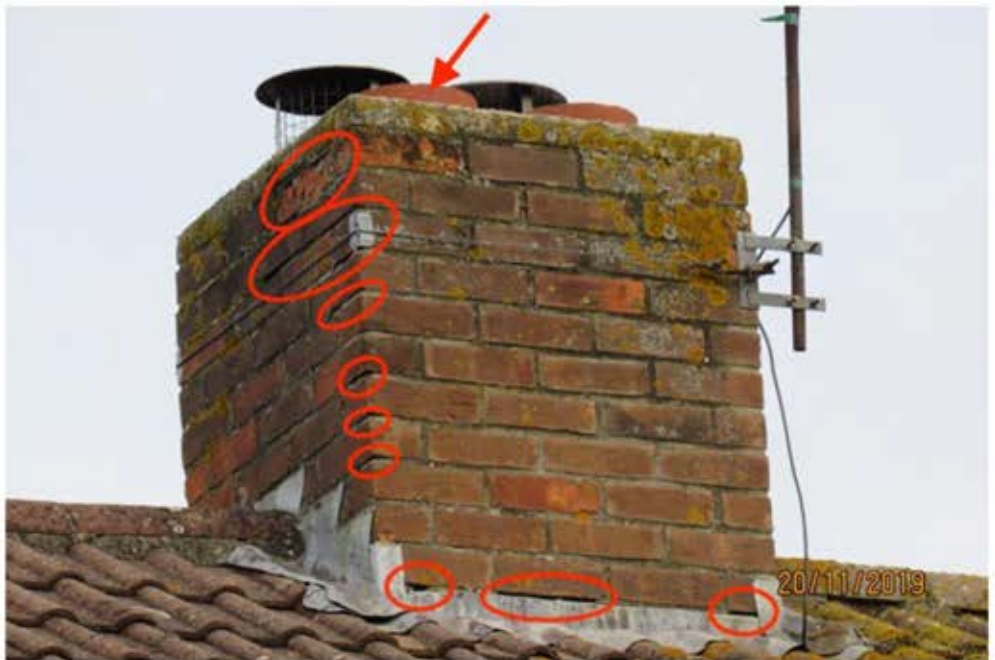
<p><b>Condition</b></p>	<p>No significant defects are noted and the chimney stacks were found to be structurally stable.</p> <p>No evidence was seen of any unusual cracking or other failure, or unusual wear to the bricks.</p> <p>The rear pot on the east stack is uncapped and open to the elements. If any pots are left uncapped then rain can penetrate the flues and damp can appear inside the property on the breasts. Providing fireplaces are regularly used then any penetrating moisture will dry out, however if fireplaces are used infrequently then it would be prudent to provide rain cowls to allow flue gases to escape but prevent moisture ingress to the flue. Fitting a cowl will also provide protection from bird and debris ingress.</p> <p>There are areas of missing mortar on the both stacks and these require re-pointing. The west stack may have some repair work done on it which has resulted in some untidy brickwork.</p> <p>The fitting of the cowl and re-pointing of the mortar can be carried out as part of the next set of ongoing maintenance or part of the work required as highlighted in section 4.2 Roof Coverings.</p> <p>The flashing at the base of the stacks is, as far as can be seen, in a serviceable condition.</p> <p>The chimney stacks should be regularly monitored for any indications of damage, instability or other defects.</p> <p>You should carry out a thorough visual inspection at least once a year, ideally in the Spring, and ideally at roof level, to identify and repair any damage that could have been caused by winter weather.</p> <p>Missing, loose or defective mortar should be repointed as necessary.</p>

Rear view of east chimney stack

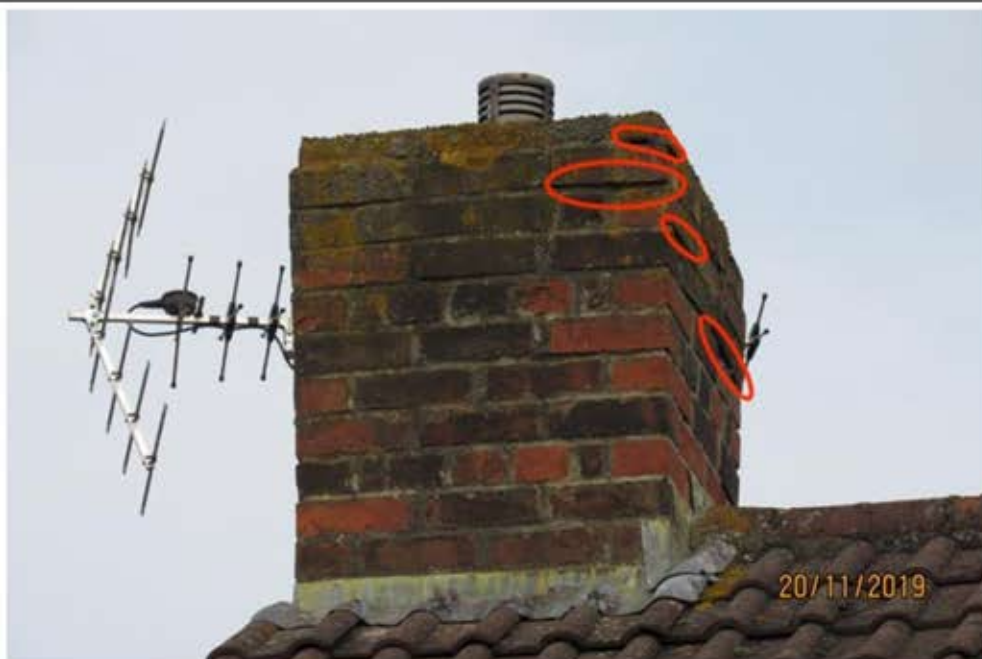
Rear view of west chimney stack

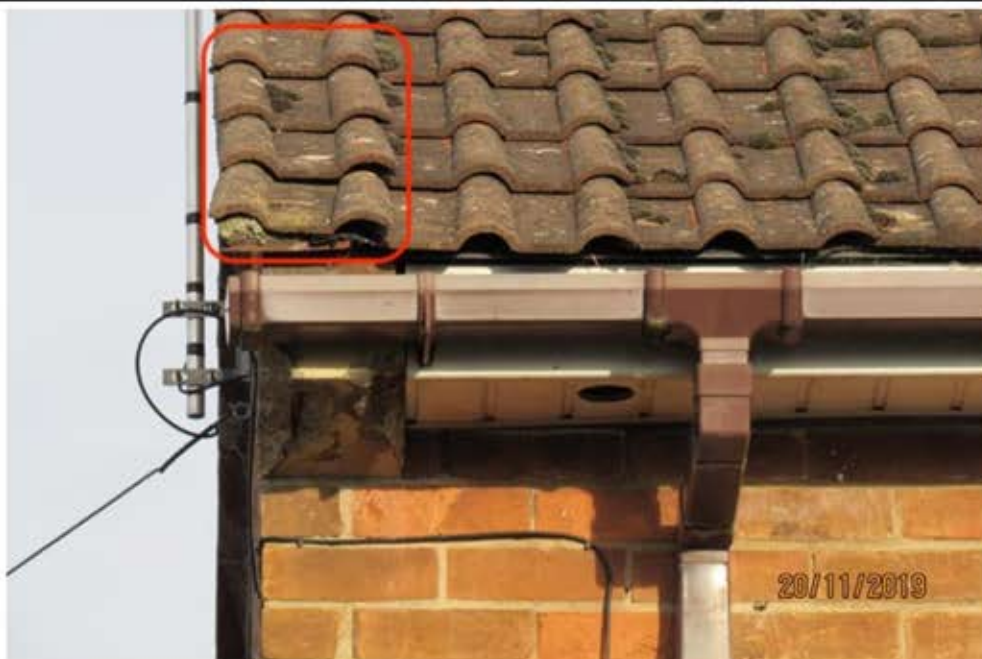
There is a small number of misaligned tiles visible at the south-west corner of the main roof.

This area seems to have had some repair work to the roof tiles and verge at some point.

Misalignment of roof tiles above south-west corner

Any slipped, missing or broken tiles on the roof pitches should be repaired and replaced.

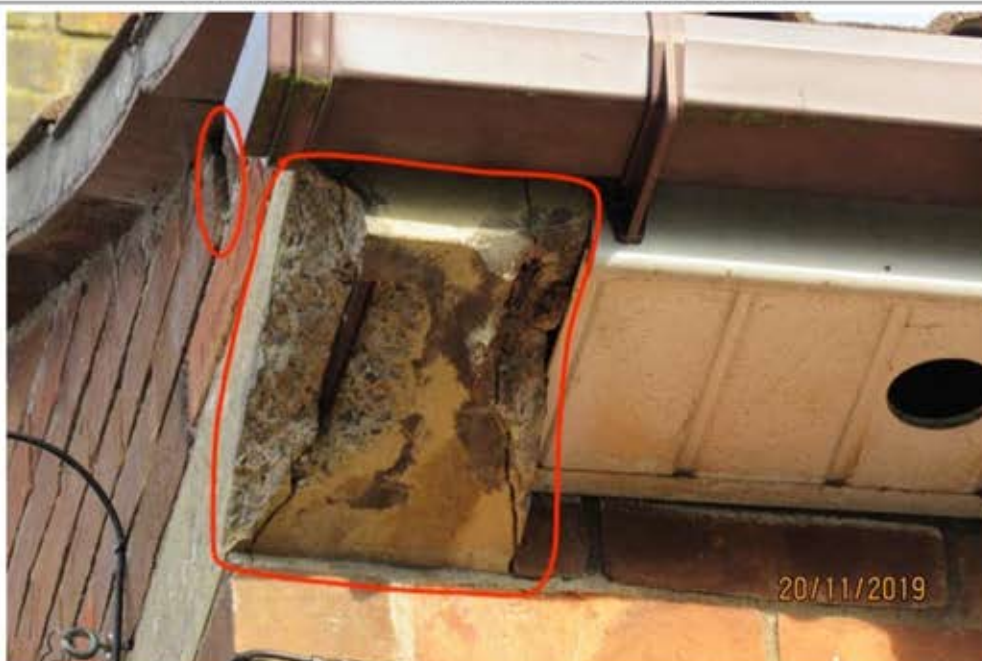
The metal reinforcing rods within the concrete corbel have rusted and caused the concrete to crack and break away in some areas. If left to deteriorate further, other sections of concrete will fall away and would harm anyone immediately below at the time. The corbel provides support to the brickwork above and this corner of the roof. There are safety and structural issues here with the added element of access which will increase costs for repair. The corbel will require specialist concrete repair work from an accredited contractor as soon as is reasonably practicable. **For these reasons, a condition rating 3 has been applied.**

Severely damaged rear Corbel and opening between bricks above

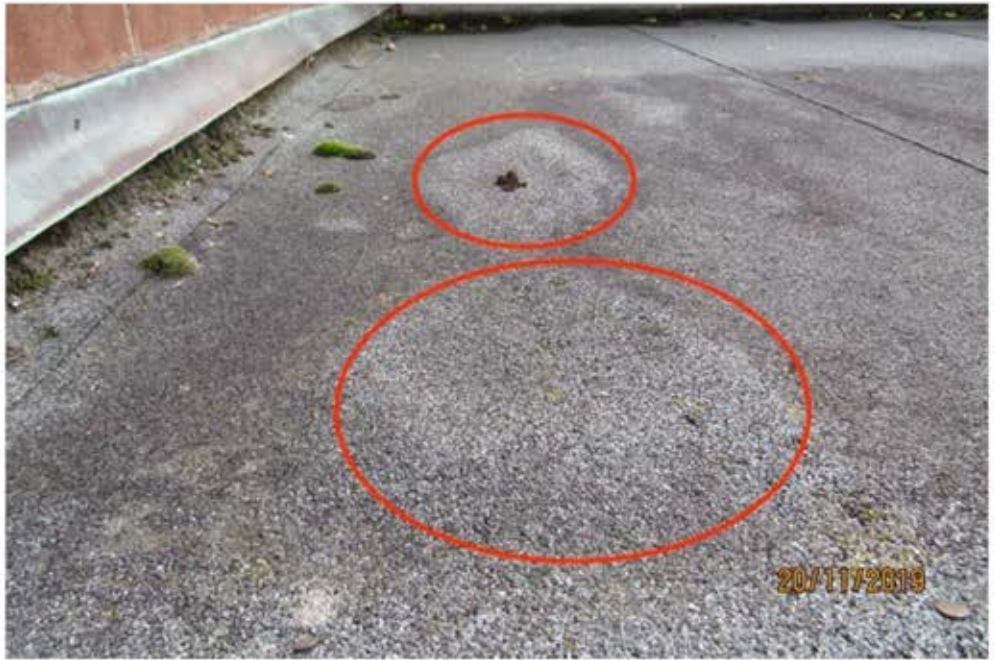
- signs of water staining and areas of moss growth suggesting ponding,
- no solar chippings have been added to the surface,
- signs of raised areas or blistering,
- a tear was noted on the wall between the flat roof and the pitched lean-to roof,
- the roof felt does not cover the abutment to the west wall.

Raised areas of flat roof felt

Built up bitumen and felt flat roofs have a limited life expectancy generally not more than 15/20 years, and they can fail within a shorter time span. It is essential to monitor and maintain this roof carefully; to add solar chippings and to repair any sections that start to show signs of blistering.

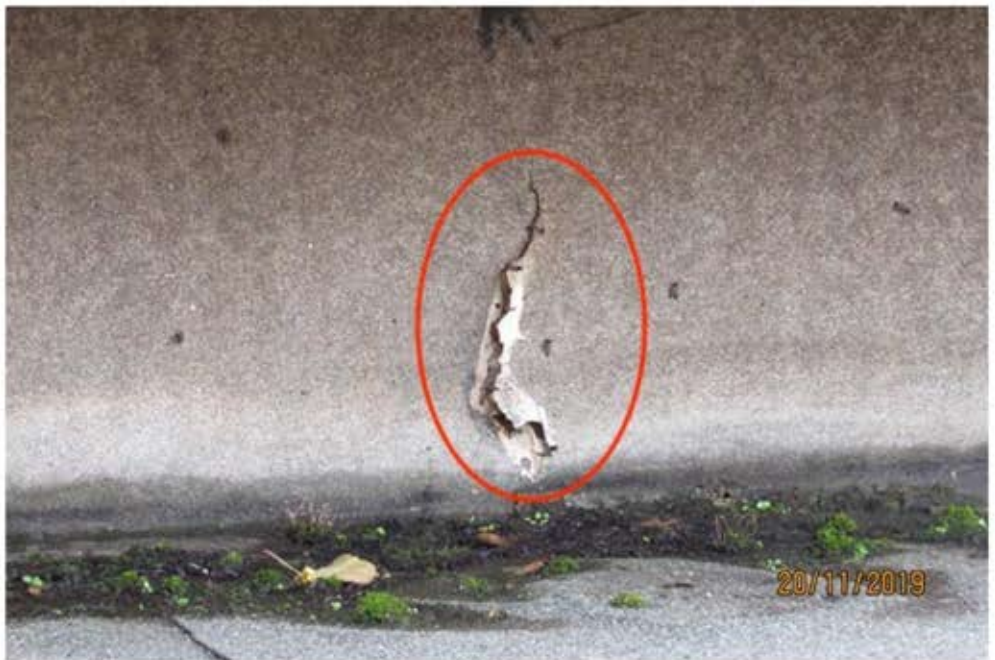
Damaged felt on wall between flat roof and lean-to roof

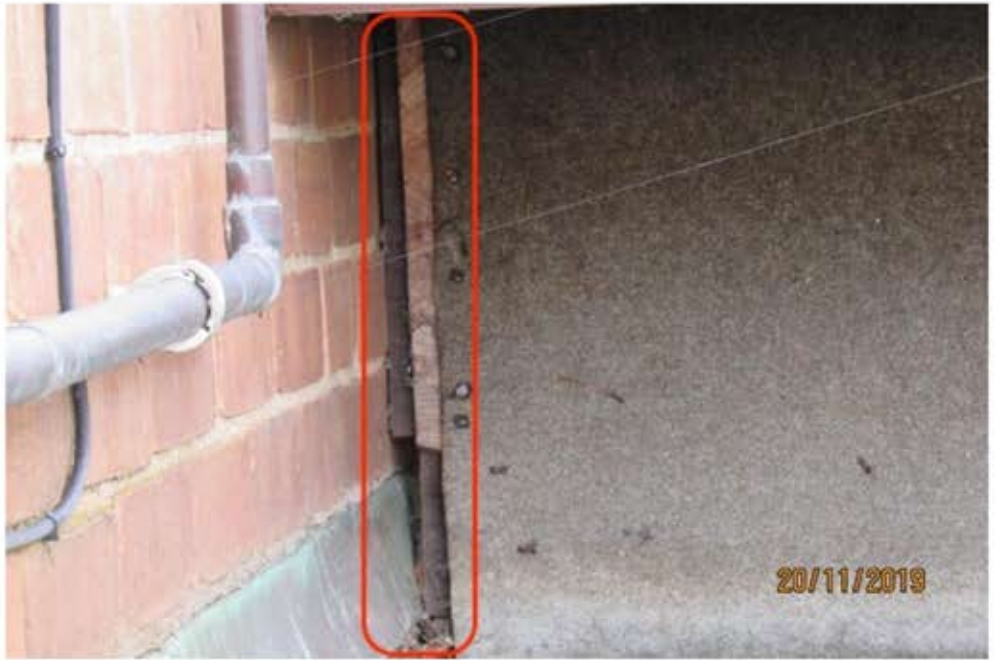
Insufficient abutment of roof felt on wall between flat roof and lean-to roof

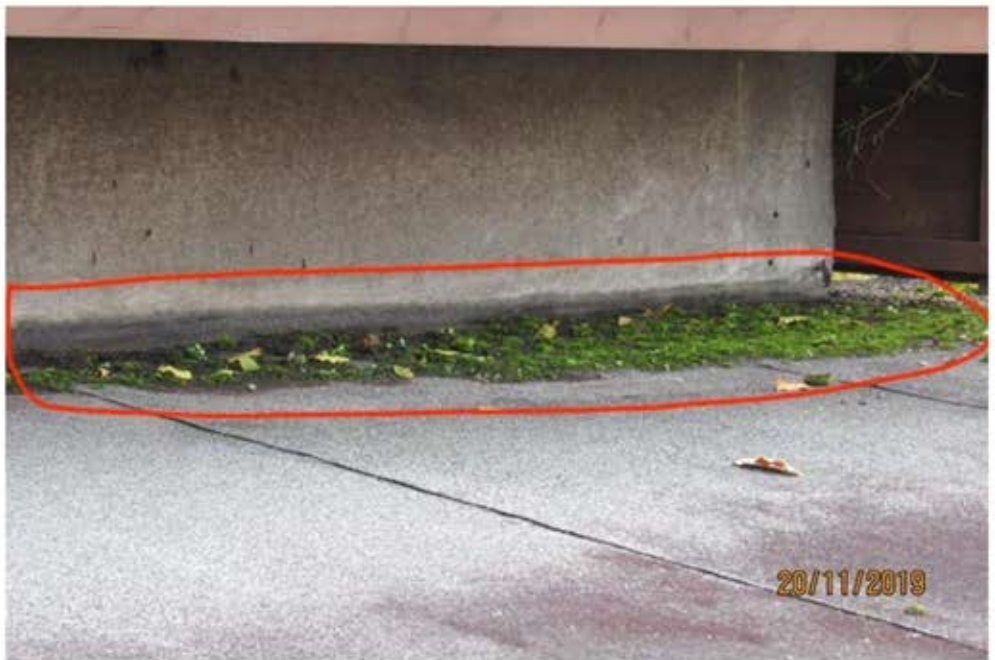
Moss growth on flat roof

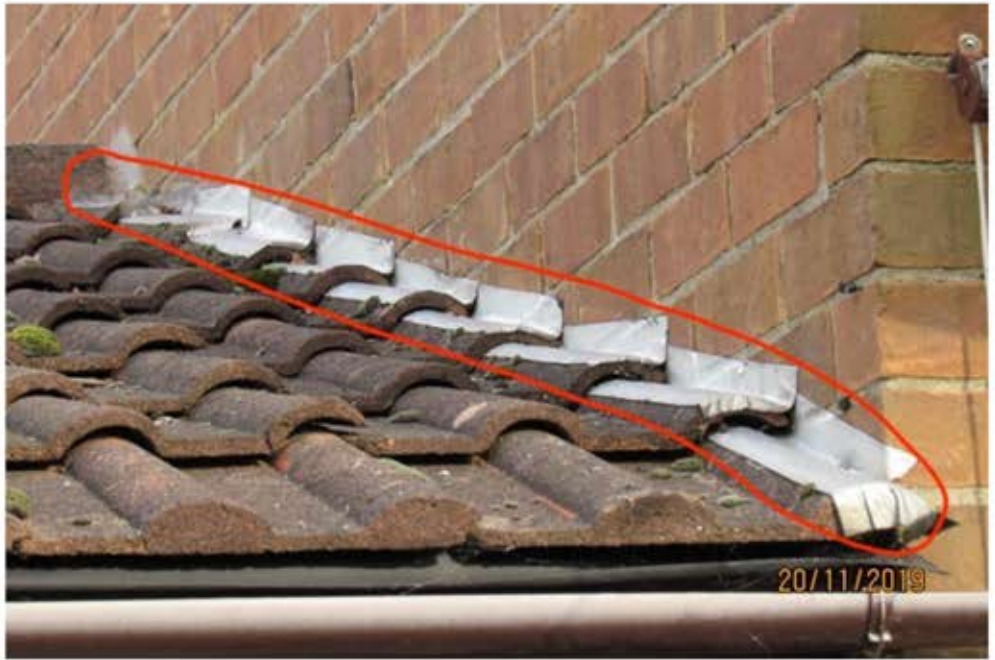
It was also noted that self adhesive 'Flashband' has been used at the junction of the roof to the west wall. While this may provide resistance to leaks for a short period, it should only be considered as a temporary flashing material which is likely to deteriorate over a period of time. This should be replaced with correctly fitted lead flashing as part of the next ongoing maintenance.

Flashband on lean-to roof

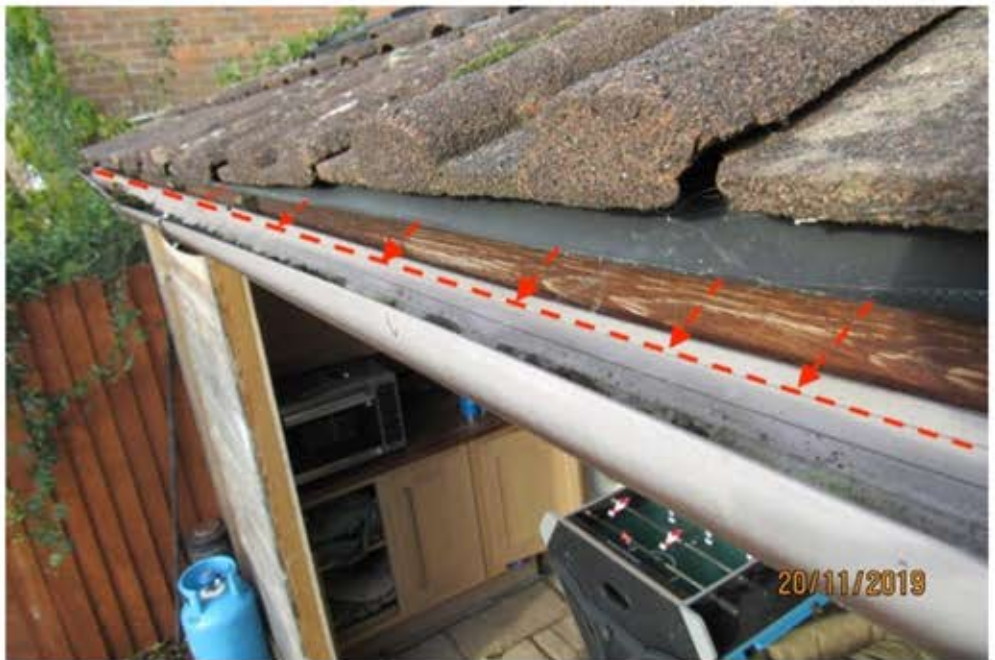
In addition, the underlay below the lean-to roof tiles does not feed in to the gutter correctly.

Incorrect position of lean-to roof underlay

From the ground level inspection, it could not be confirmed that the underlay material (underneath the roof tiles) feeds correctly in to the gutters. When present, the edge of the underlay should feed in to the gutters to transfer any water away from the fabric of the property. Ideally, a plastic support tray system (eaves protector) should be installed above all the gutters to reduce the risk of water penetration leading to rot or other defects in nearby timbers.

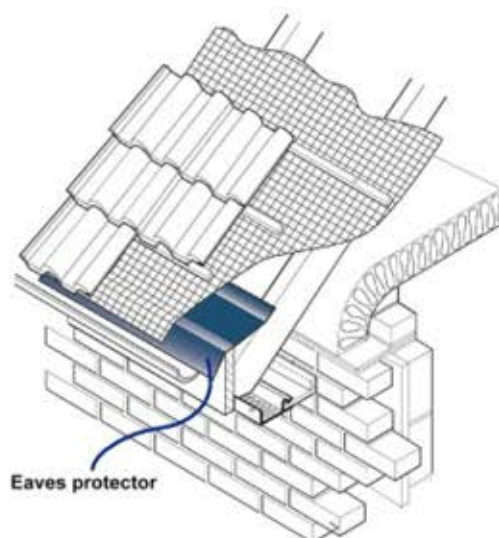
Eaves protector

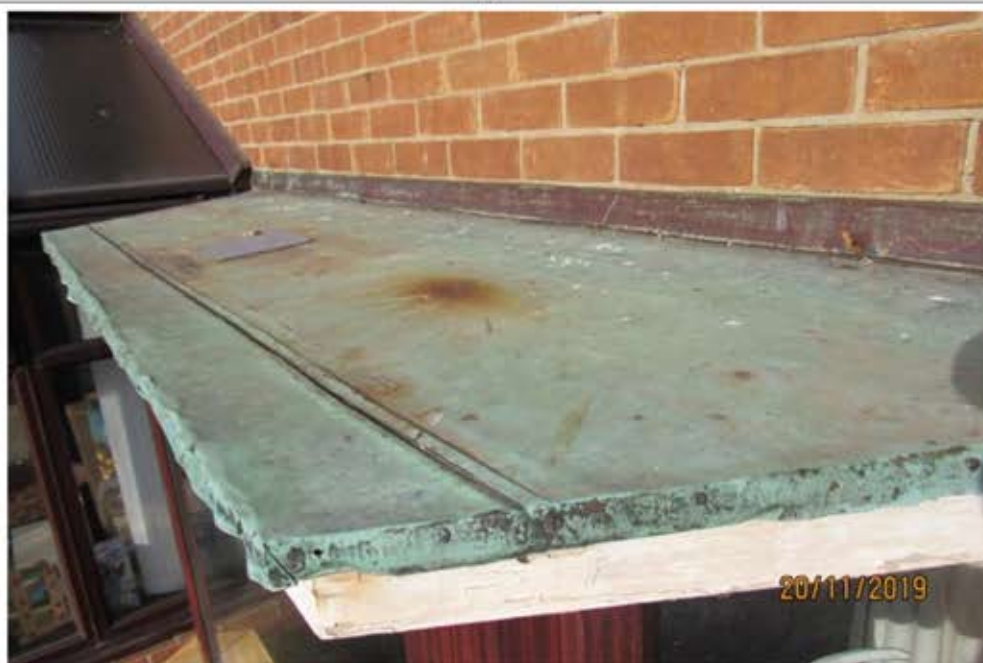
The copper covering is very weathered and shows areas of previous repair. The timber structure is in very poor condition and the roof is no longer securely fixed to the decaying timber frame. Although there is no evidence of internal issues at present (such as damp ingress), you should consider budgeting for the re-roofing of the bay window within a year. As mentioned above, the supporting structure may also need some attention.

Weathered copper covering to bay window roof

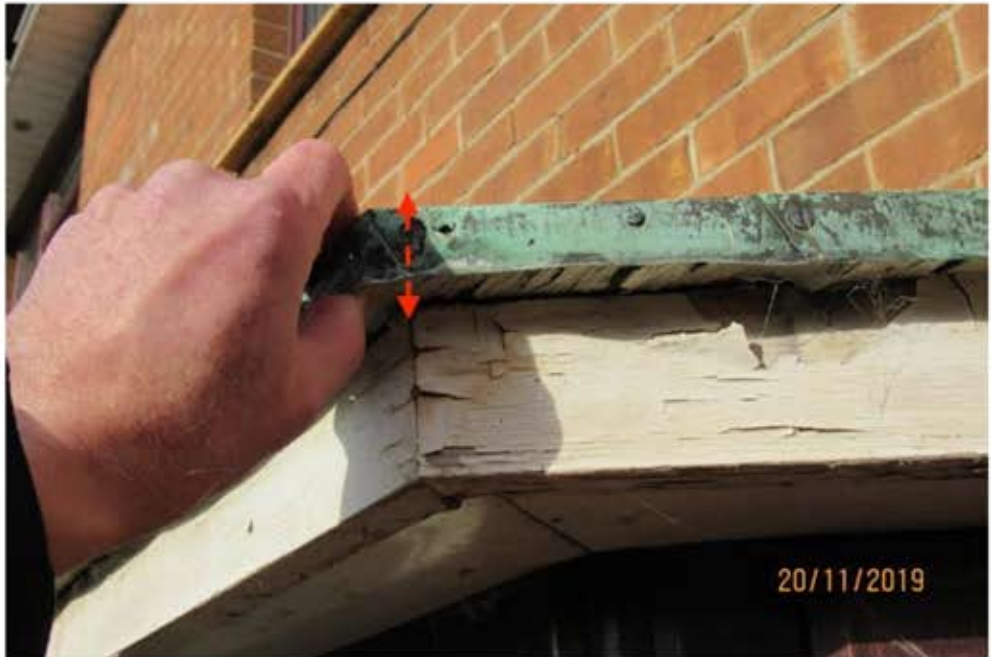
Bay window roof insufficiently fixed and timber frame decaying
